REPORT ON THE
REMEDIAL INVESTIGATION
OF THE
ROSE CHEMICALS SITE
HOLDEN, MISSOURI
APPENDIX E - BUILDINGS AND STRUCTURES INVESTIGATION
TECHNICAL MEMORANDUM

CLEAN SITES, INC.

February 1990

Burns & McDonnell Engineering Company
Engineers-Architects-Consultants
Kansas City, Missouri

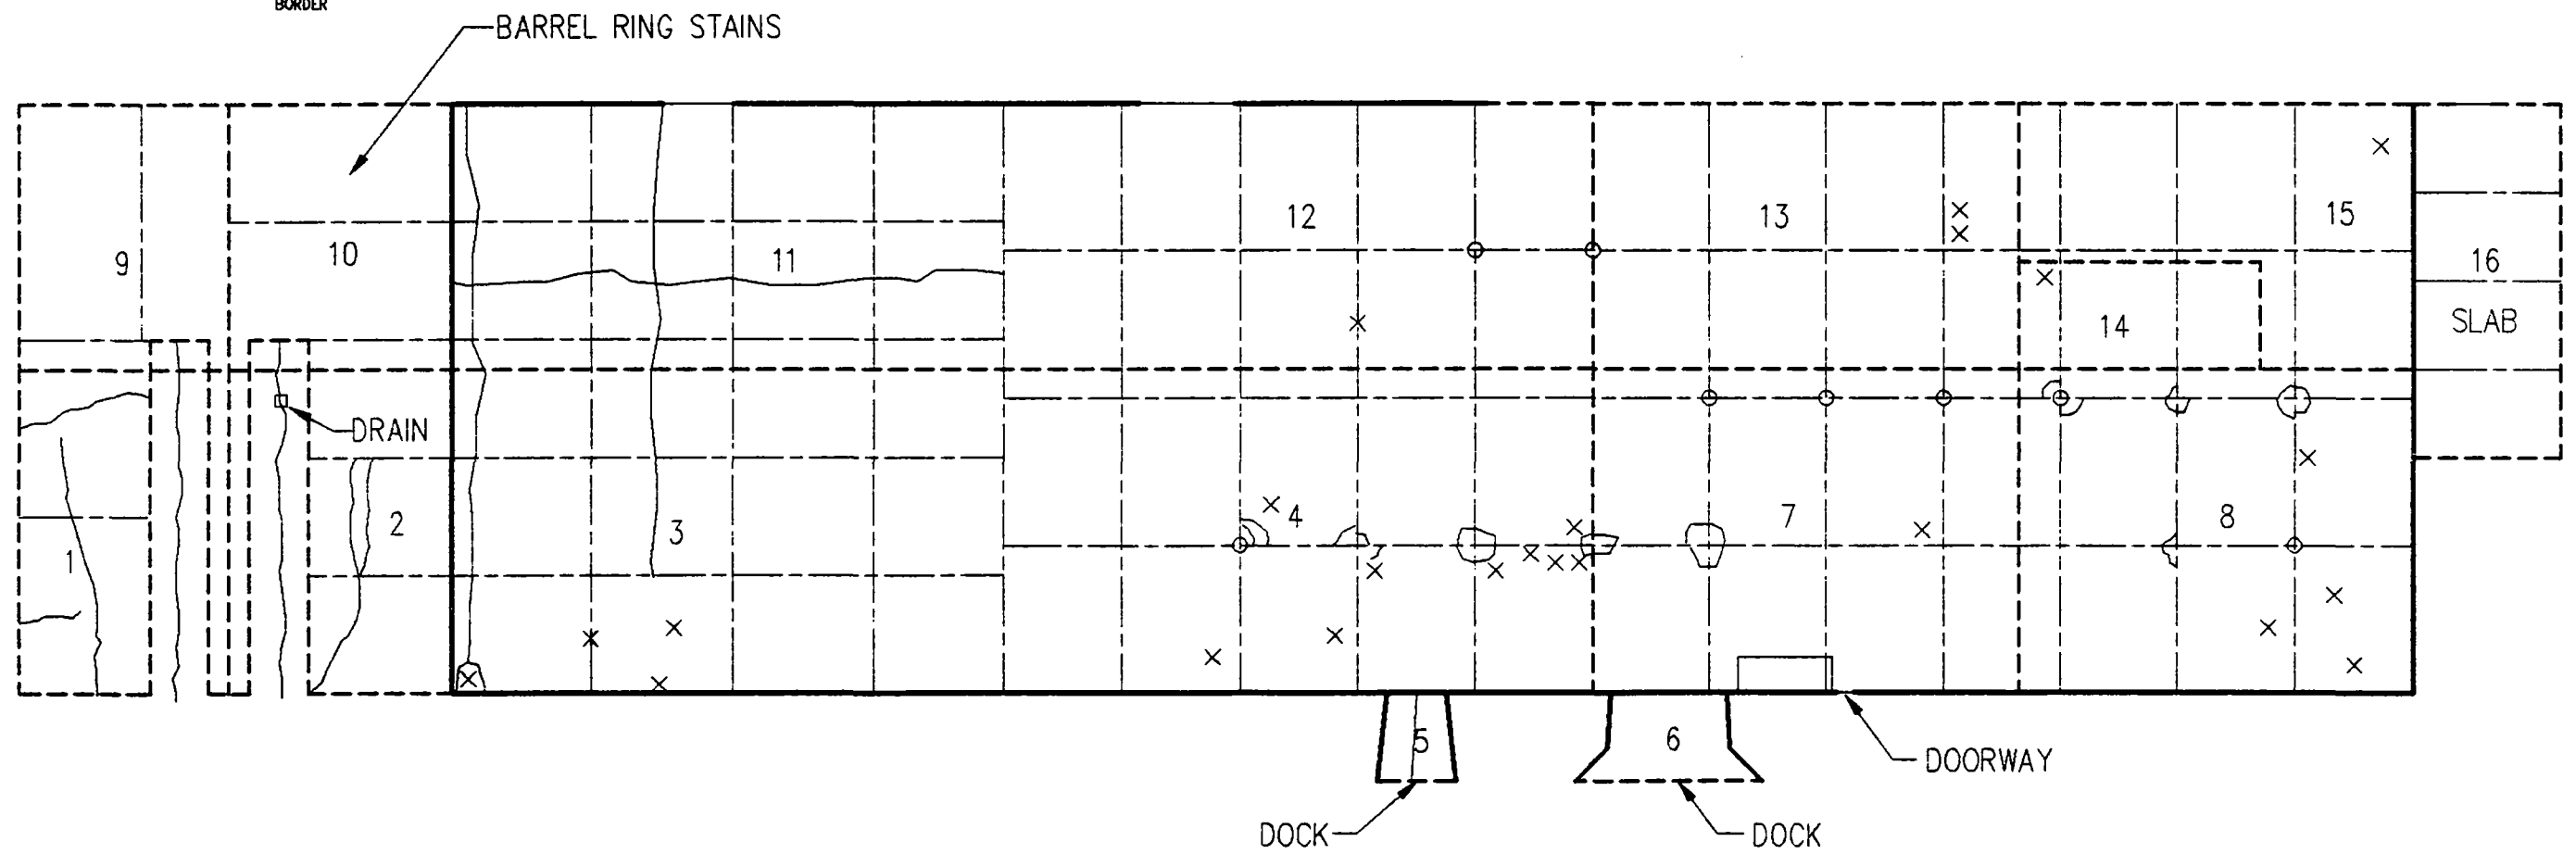
FIGURE III-2
AREA A
INSPECTION AREA
DETAIL OF THE
MAIN BUILDING

Warehouse (see Figure III-6). These stains were oily and beaded water in some cases. A drain in the loading dock area of grid 2 of the Main Building (see Figure III-2) was noted. A suspected degreasing pit was located in the northwest corner of grid 38 in South Warehouse (see Figure III-6). The photographs in Appendix A illustrate typical cracks and stains found during the inspection. Also pictured are the drain and pit mentioned above.

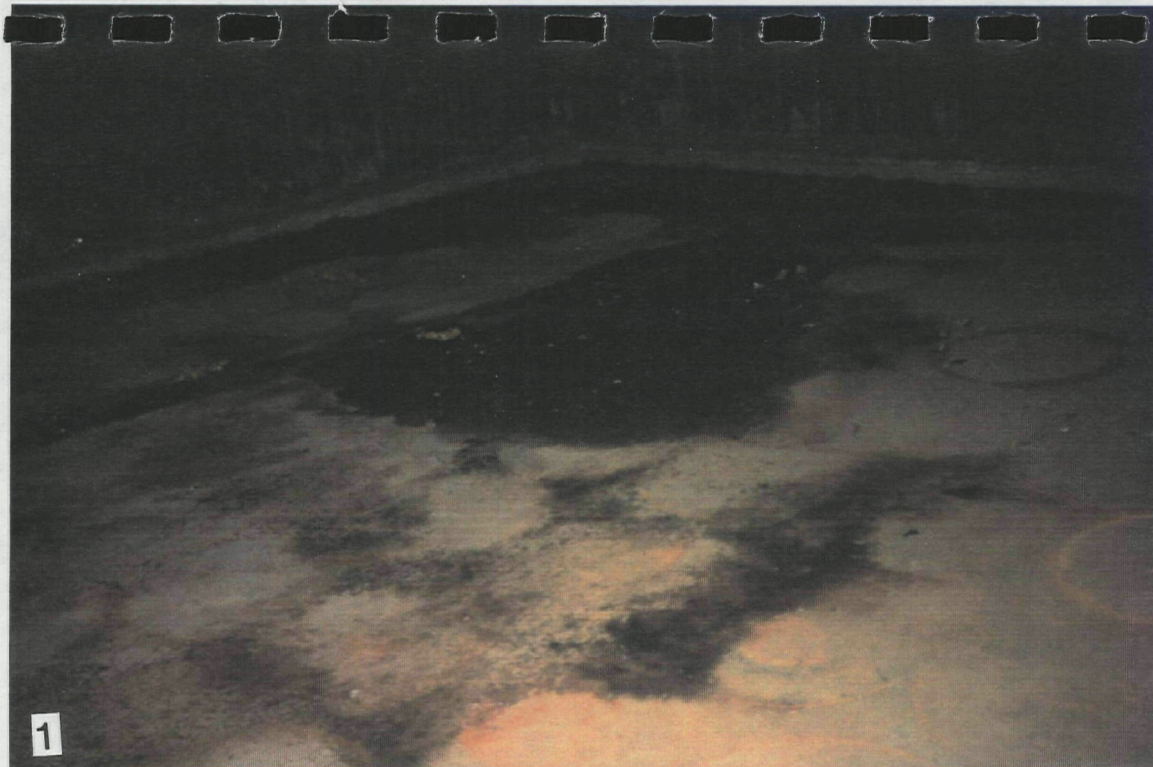
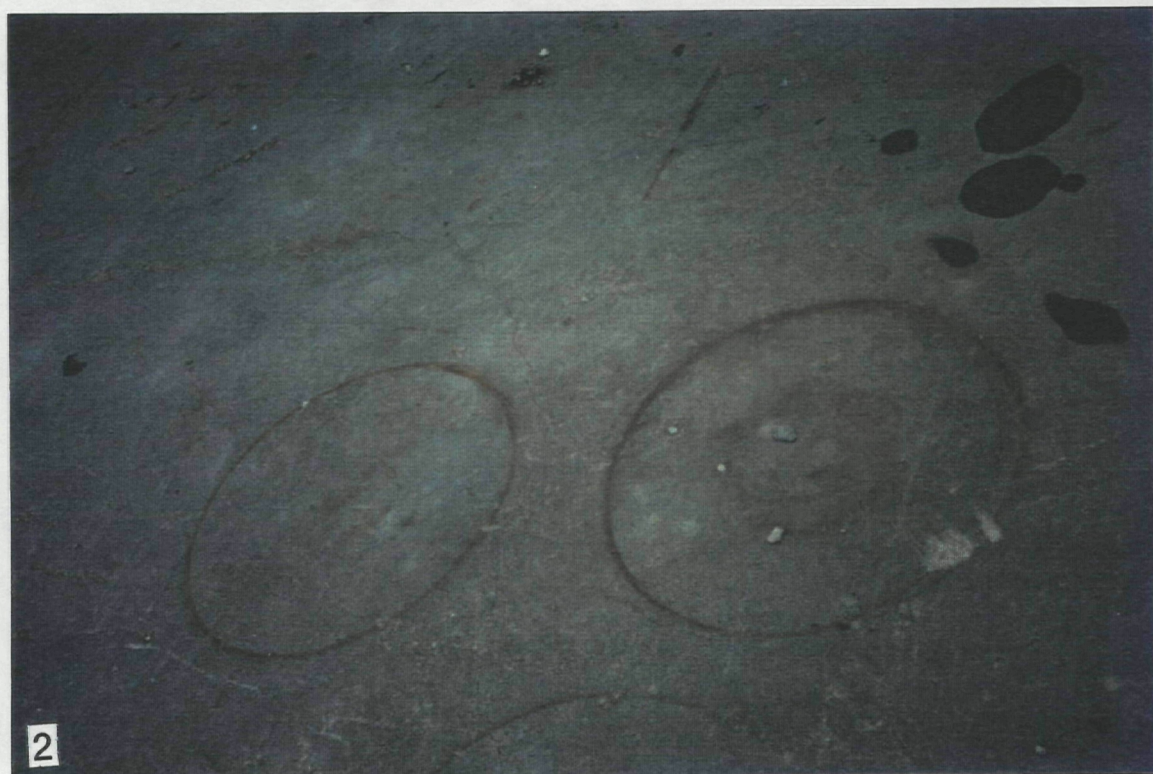
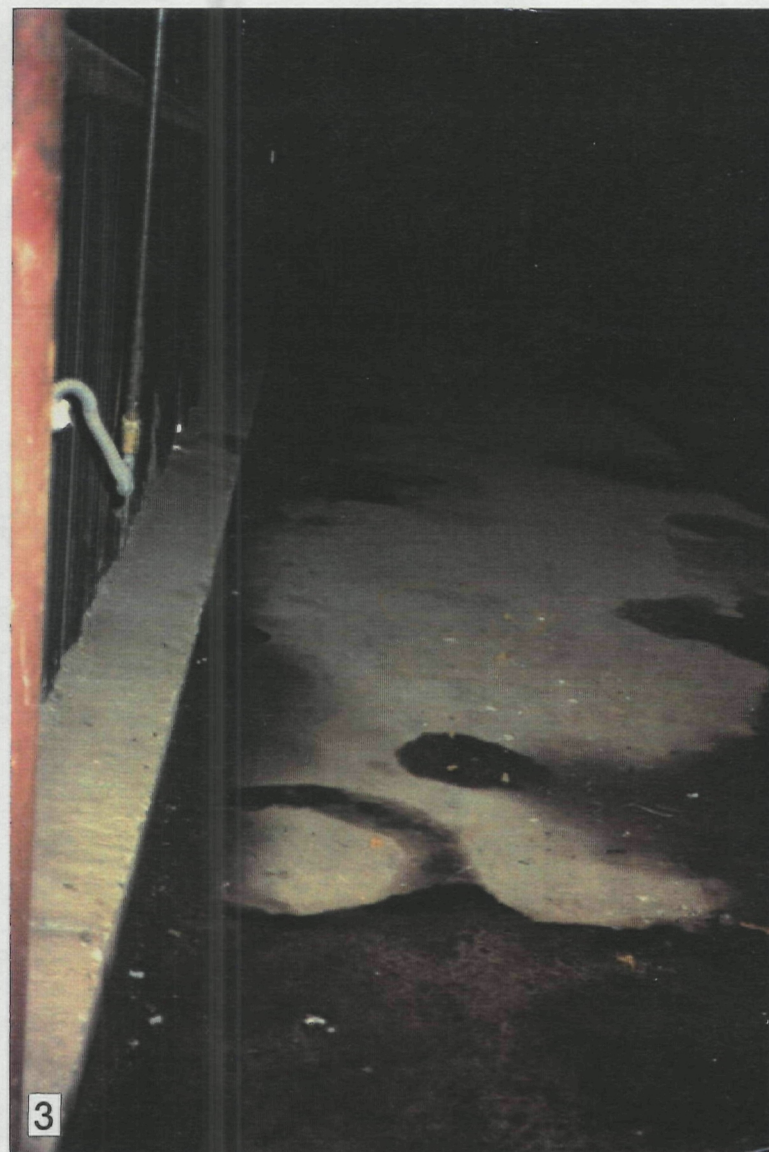
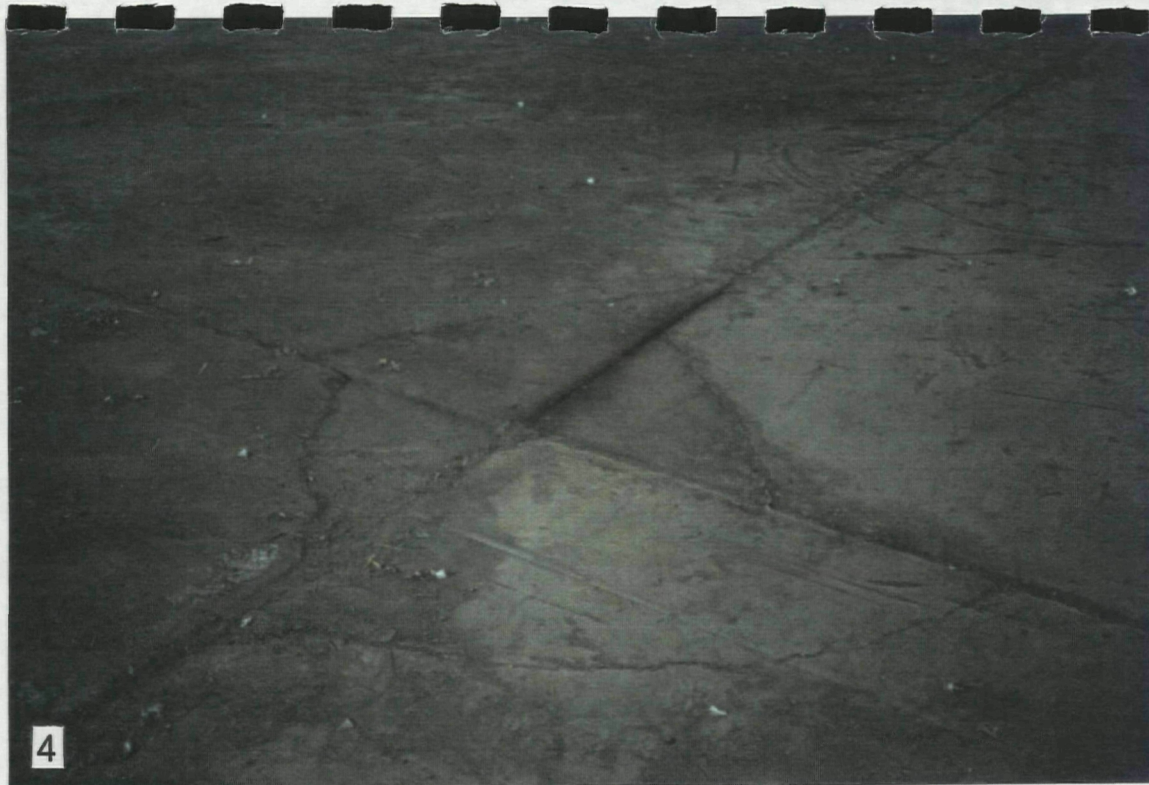
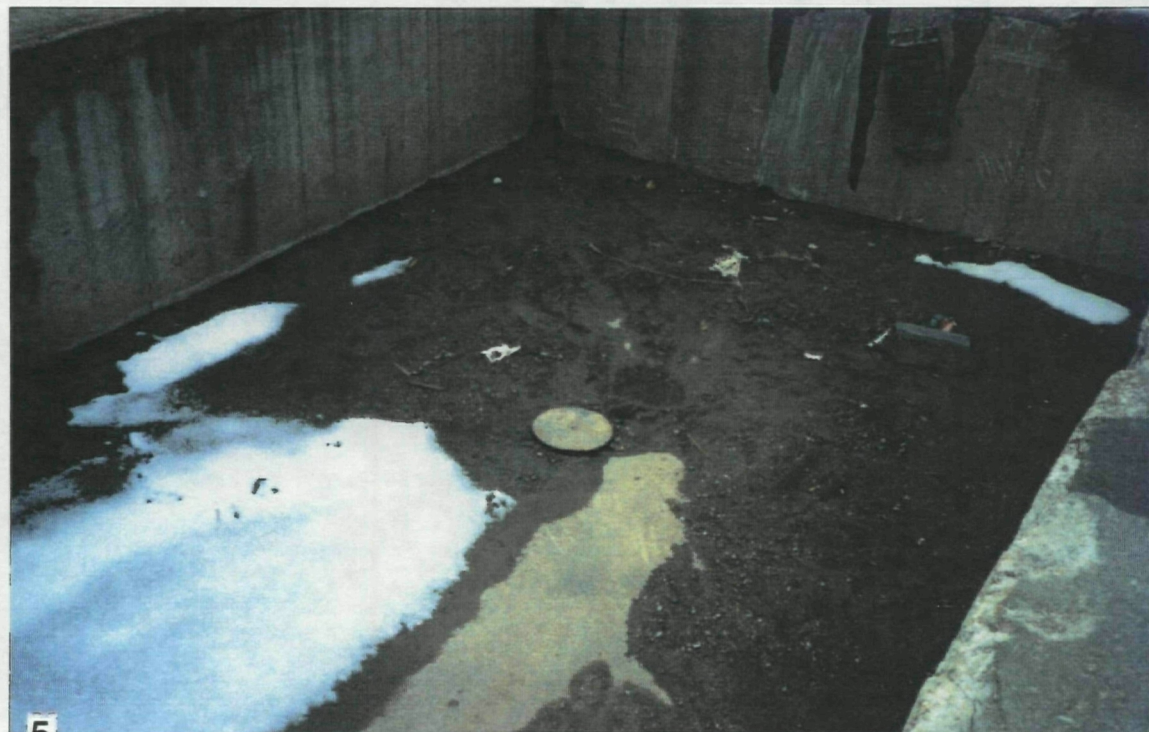
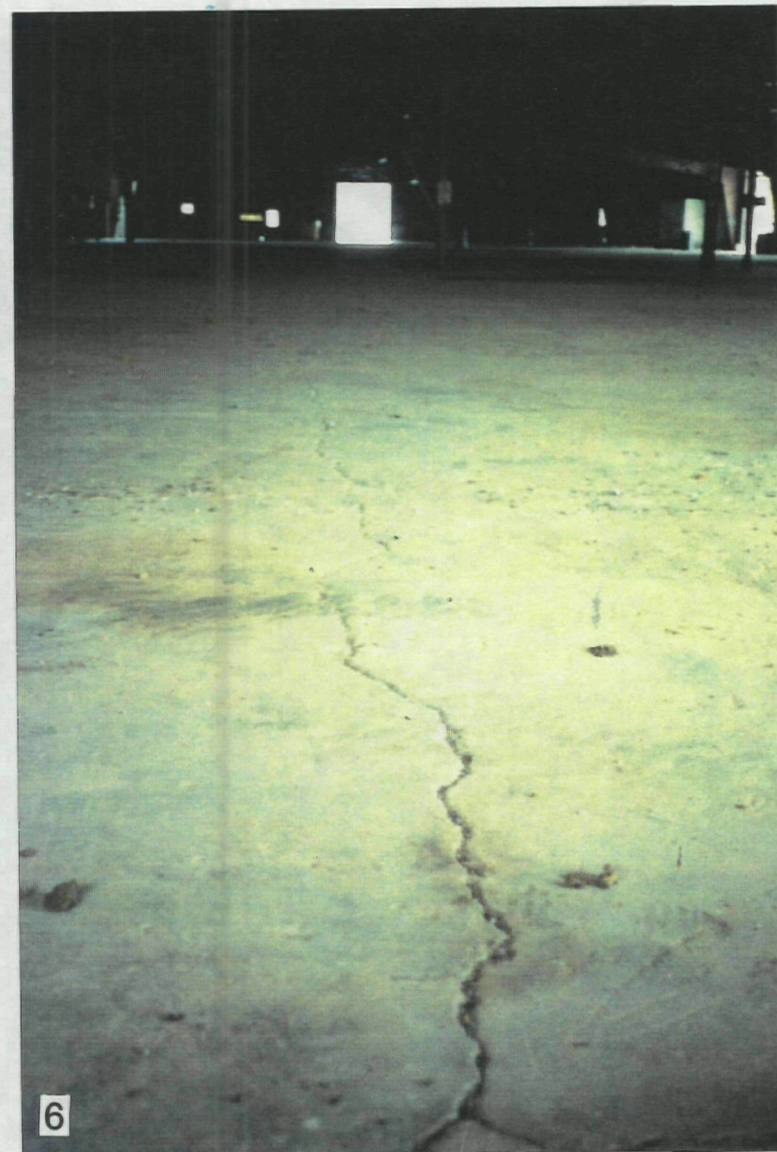
Rose Chemicals Site
Photographic Log of Major Findings
Buildings Inspection

Photo No. -----	Description -----
1	Stained area in northwest corner of Grid 40, South Warehouse.
2	Rust rings from barrels, near middle of Grid 2, Main Building.
3	Stained area along north wall of Grid 40, South Warehouse.
4	Cracks at concrete seam intersection in Grid 3, Main Building.
5	Drain in ground level area of Grid 2, Main Building.
6	Crack in concrete extending across Grid 11, Main Building, looking east.
7	Stain in northeast corner of Grid 33, Main Building.
8	Stain in Grid 33 with water "beading" on the surface Main Building.
9	Sump in northwest corner in Grid 38, South Warehouse
10	Remaining linoleum floor covering in Grid 14, Main Building.
11	Stained area near open trench in Grid 28, Main Building
12	Stained area along concrete seams on south wall of Grid 32, Main Building.

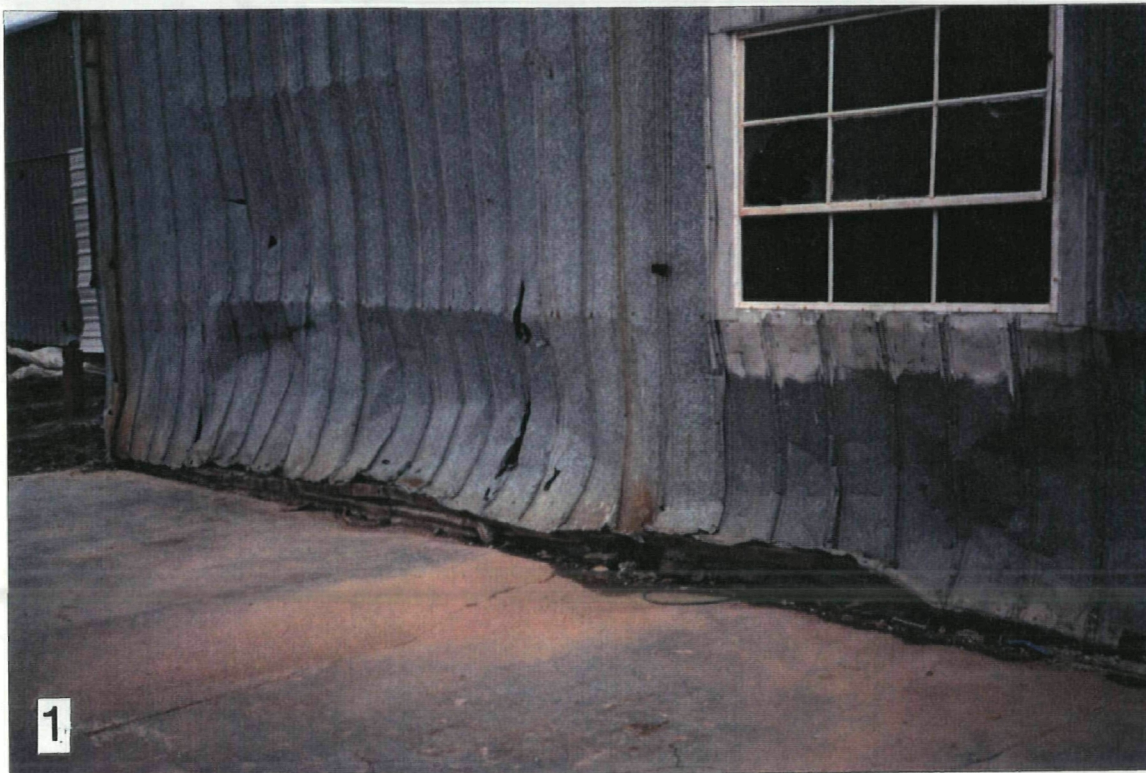
1. The main rigid frame members, purlins and girts generally appeared to be in fairly good condition. Some corrosion was noted.
2. Several open holes and damaged areas in the metal siding were noted. One such location is at the west end of Area A (Refer to Photograph #1).

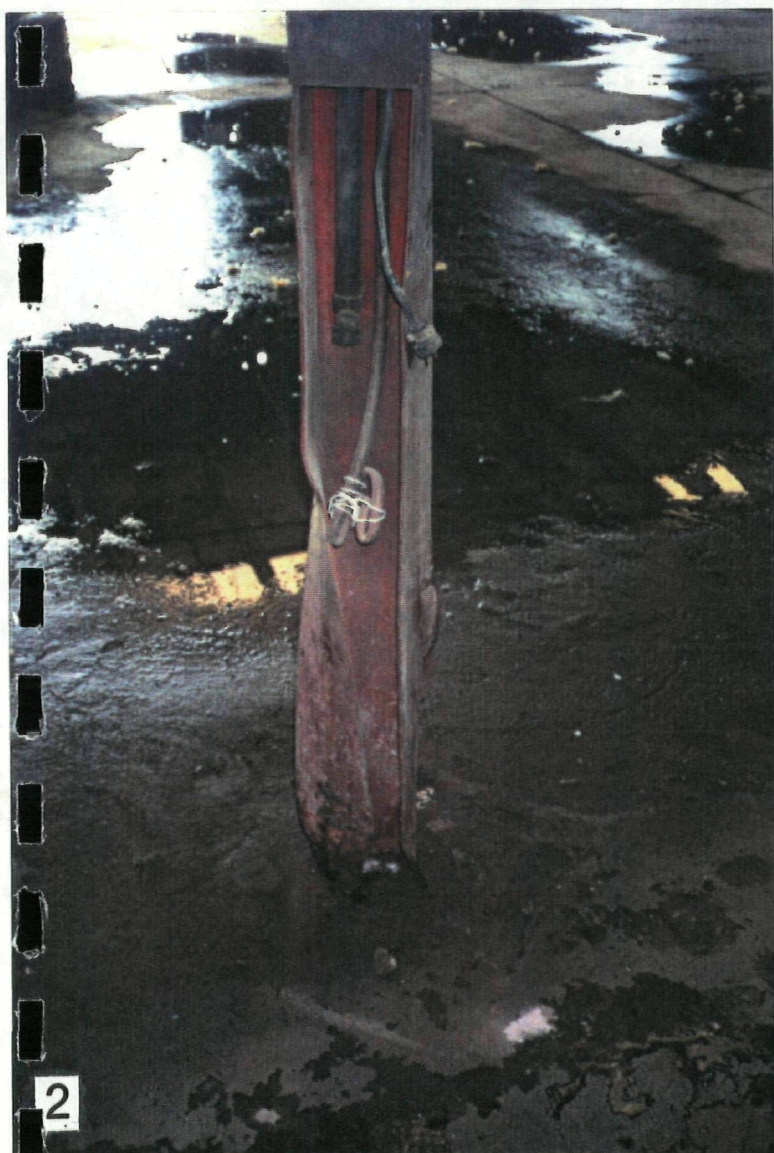
3. Three interior steel columns under the ridge line were noted to have damage in the form of bent flanges. Damage was generally located at the bottom portions of the columns (Refer to Photograph #2).

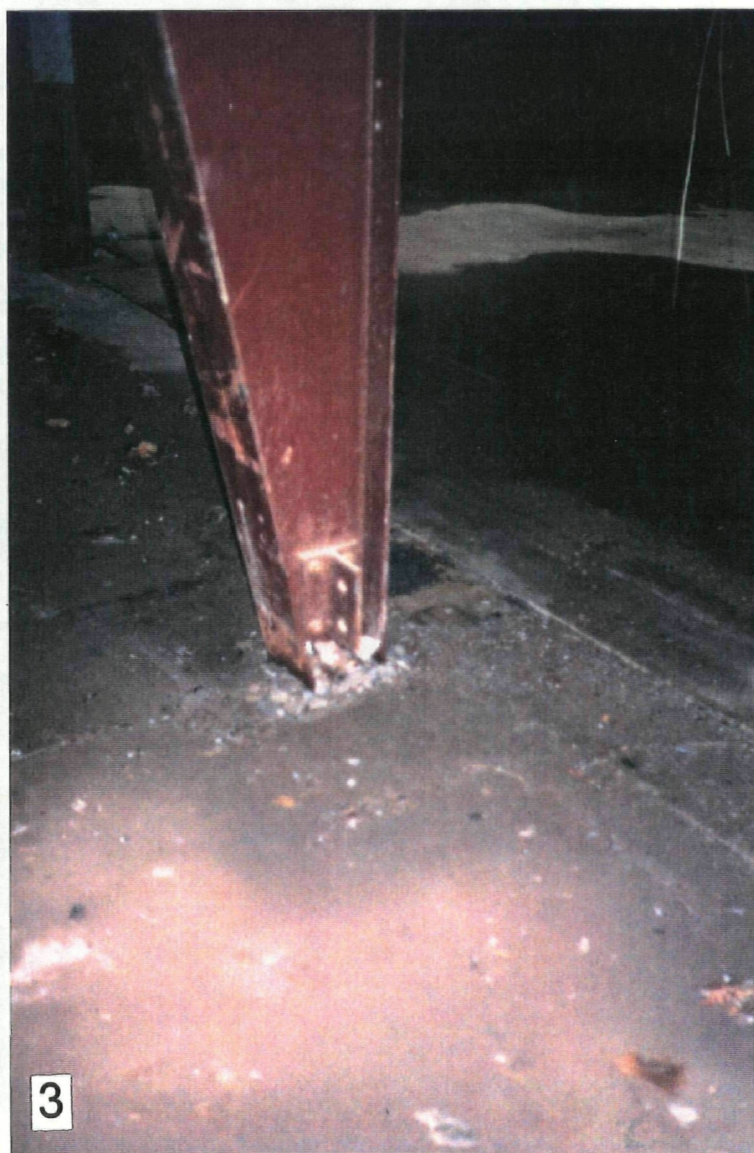
4. Several irregularities and damage were noted regarding the wind bracing for Area A, which may adversely affect lateral stability.
 - a. At two bays on the north side of Area A, the vertical wind X-bracing between rigid frame columns appears to have been removed at some time, although some of the connection plates still remain in one location (Refer to Photograph #3).
